# Automated Vehicles and Adverse Weather – Phase 3

**Atmospheric and road weather conditions can adversely affect vehicle and driver behavior.** The Automated Vehicles and Adverse Weather – Phase 3 project sought to identify how automated vehicles (AVs) -- i.e., vehicles with automated driving systems will detect and react to adverse weather and road weather conditions, as well as different traffic scenarios. Two rounds of field tests were conducted to challenge AV perception systems with artificial and controlled adverse weather and different traffic/roadway configurations at a controlled outdoor laboratory setting. The first round of field tests were conducted in the Spring/Summer of 2020, and the second round of field tests were conducted in the Winter of 2020/21. Both field tests were conducted at Transportation Research Center, Inc. (figure 1).

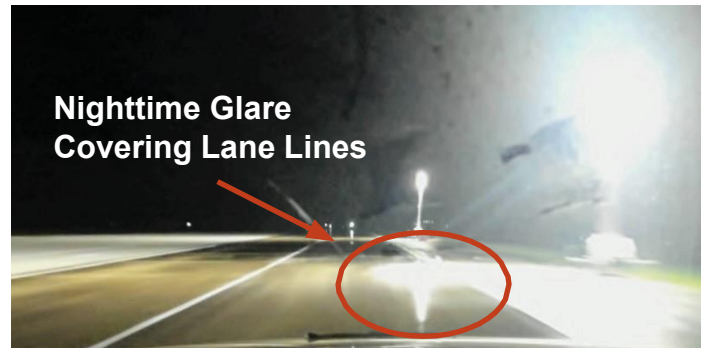
Figure 3. Nighttime glare conditions covering lane lines and creating perception challenges for test vehicles during Summer Field Test #1. Source: FHWA

1. Limitations of the test vehicles were successfully challenged through exposure to adverse weather conditions (figure 3).
2. A potentially significant amount of inconsistency in the test vehicles' performance was found, both across vehicles and between runs for a single vehicle. Summer Field Test #1 Vehicle B produced better performance than Summer Field Test #1 Vehicle A. (figure 4).
3. Sizeable differences in the test vehicles' approaches to automation and driver assistance functionality were evident.

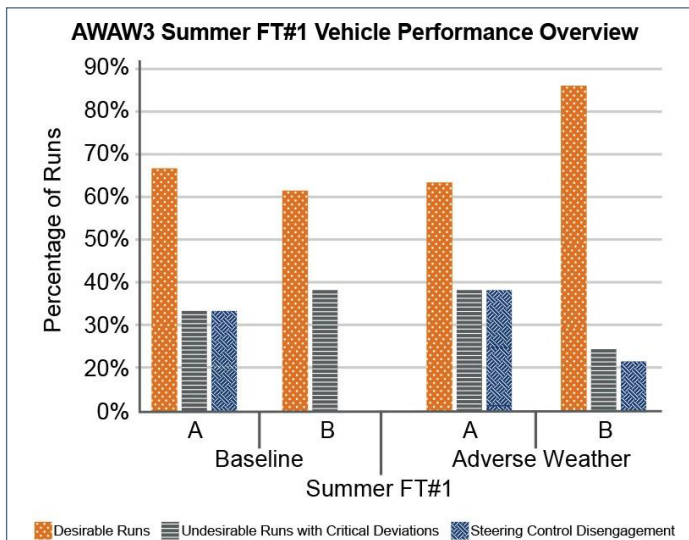
Figure 4. Summer Field Test #1 Vehicle B producing more desirable runs than Summer Field Test #1 Vehicle A during Summer/Spring weather conditions. Source: FHWA

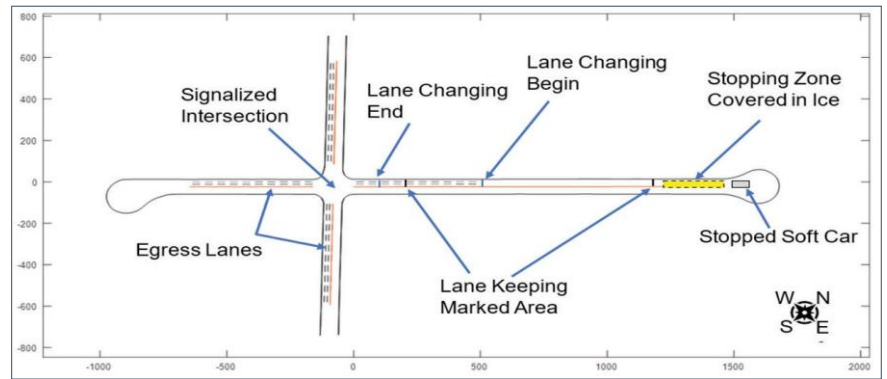
Figure 5. Winter Field Test #2 Test Track Layout. Source: FHWA

The second round of field testing was performed between January 28 and March 3, 2021, at the Smart Mobility Advanced Research and Test Center test facility (circled in figure 1). The test track has a signalized intersection with six 12-ft-wide lanes on all four approaches (figure 5).

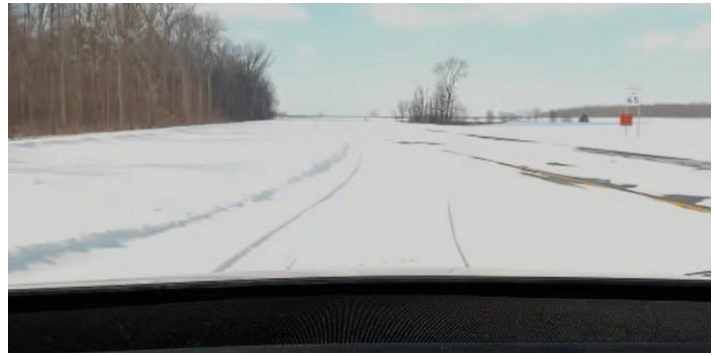
Figure 6. Winter Field Test #2 Vehicle A following the piled up snow in the travel lane and deviating to the adjacent lane. Source: FHWA

1. Limitations of the test vehicles were successfully challenged through exposure to adverse weather conditions (figure 6).
2. A potentially significant amount of inconsistency in the test vehicle performance was found, both across vehicles and between runs for a single vehicle. Inconsistencies included:

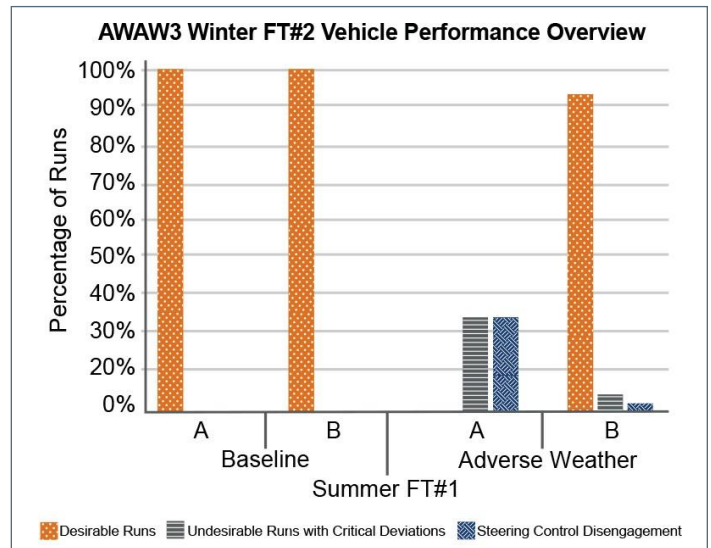
Figure 8. Winter Field Test #2 Vehicle B producing more desirable runs than Winter Field Test #2 Vehicle A during adverse winter weather conditions. Source: FHWA

- Rapid accelerations and decelerations at snow-covered intersections
  - Inability to drive close to centerline on roadways with varying snow depths
3. Winter Field Test #2 Vehicle B was able to capture, assess, and react to adverse weather and road weather conditions more efficiently than Winter Field Test #2 Vehicle A (figure 8).
