# **SIGNS OF RAIN.**

**Dr Graham Brisbane. B.Eng. M.I.E. (Aust), F.A.I.T.P.M. and  
Andrew Vasiliou B.Eng. B.Comp.Sc. M.I.E. (Aust)**

## **DYNAMIC WARNING SIGNS**

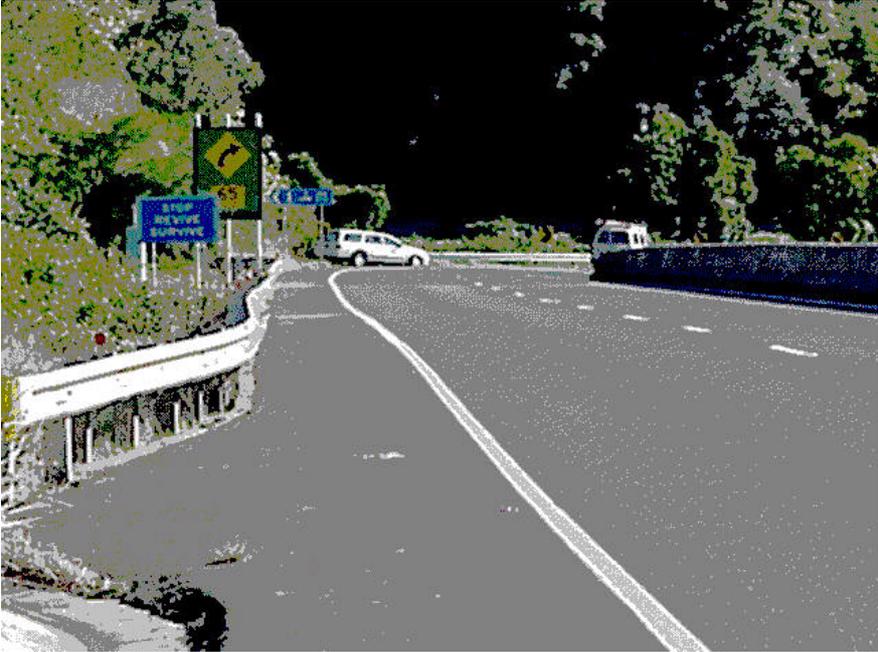
FIG 1: Selected Site

The selected site contains a right hand curve on a 4 lane section of the Princes Highway separated by a New Jersey kerb. Annual rainfall is in the order of 120 cm. There is an AADT in excess of 13000 vehicles per day. A curve warning sign is currently located in the approach to the curve with an advisory speed of 65 km/hr.

Within the Kiama bends section, 17 of the accidents occurred at the location selected with 10 of those occurring in the Northbound direction.

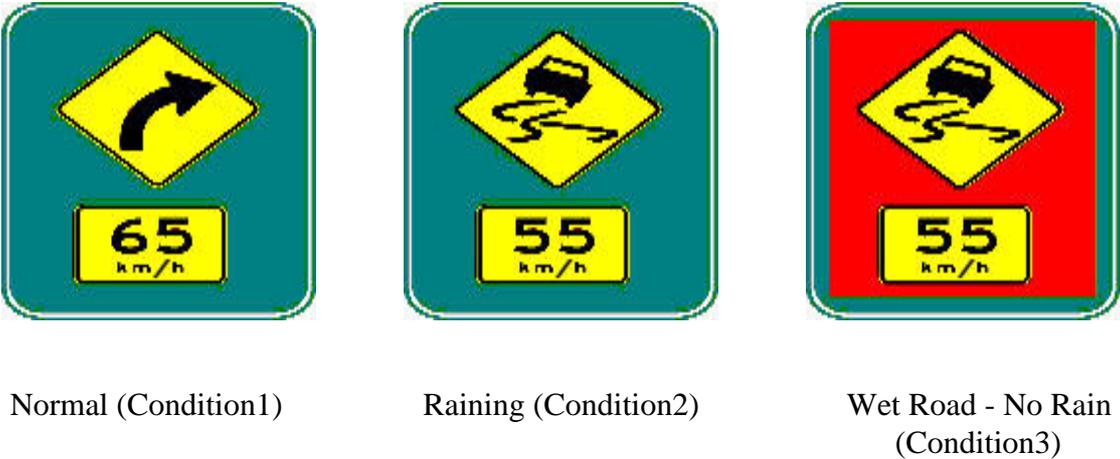
FIG 2: Variable Sign Arrangement

In establishing the trial site the sign has been converted to a three way sign with displays shown as shown in Fig 2.

The different displays are activated by a moisture detection device that is able to detect weather conditions and the amount of precipitation when raining as well as the pavement conditions in terms of dry/moist/wet. (The equipment is also capable of detecting other conditions such as frost and snow which are not relevant at this site.) Details of the display triggers are shown in Table 2. Flashing Lights are attached to the sign for use in the third mode which is assessed as the most dangerous situation (See later comments).
