Next-Generation Traffic Incident Management

VIDEO SHARING TECHNOLOGY ENHANCES TRAFFIC INCIDENT MANAGEMENT

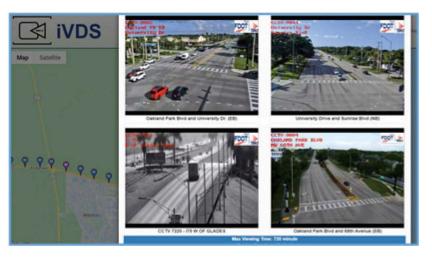
Source: Florida Department of Transportation

Custom software applications have been created that allow responders in the field to log into web services and get high-quality TMC images from any camera in a geographic area. Multiple camera views can be combined to build a custom "video wall" on a responder's computer. This type of video sharing enhances the ability of responders to evaluate incidents, plan their response, and identify the need for additional resources.

- The Maryland Department of Transportation's Coordinated Highways Action Response Team (CHART) has installed cameras on most of their service patrol vehicles and found it to be beneficial for supplementing fixed camera installations.
- The Florida Department of Transportation developed an application that allows responders to access TMC video images in their vehicles through a secure login. Responders can monitor their coverage areas by selecting specific camera locations and building a custom video wall.
